INDIAN BUREAU OF MINES MINERALS DEVELOPMEMT AND REGULATION DIVISION FMCP REPORT

Mine File No. Minecode: 38HPR10012

1	(a)	Mine Name	Hiyona Limestone Mines
	(b)	Registration No.	The one difficulty whites
	(c)	Category	A-Category
	(d)	Type of Working	Opencast
	(e)	Postal Address	- Spinoust
		State	Himachal Pradesh
		District	Sirmour
		Village	Mauza Barwas
		Taluka/Tehsil	Poanta Sahib
		Post Office	Poanta Sahib
		Pin Code	173001
		FAX No.	NA
		E-mail	Kapilanand51@gmail.com
		Phone	NA
	(f)	Police Station	Poanta Sahib
	(g)	First Opening Date	NA
	(h)	Weekly day of rest	-
2		Address for Correspondence	Kapil Anand
			R/o Bata Mandi
			Tehsil-Poanta Sahib
			District-Sirmour
			Himachal Pradesh-173001
3	(a)	Lease Number	-
	(b)	Lease Area	18.21 hect.
	(c)	Period of Lease	Up to 05.11.2023 As per Section 8(A)(6) of MMDR Act-2015.
4		Mineral Worked	Limestone

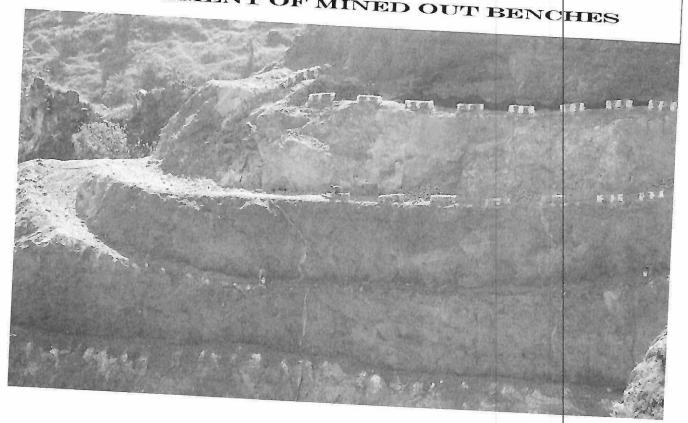
FMCP HIYONA LIMESTONE MINE:

MANAGEMENT OF MINED OUT BENCHES

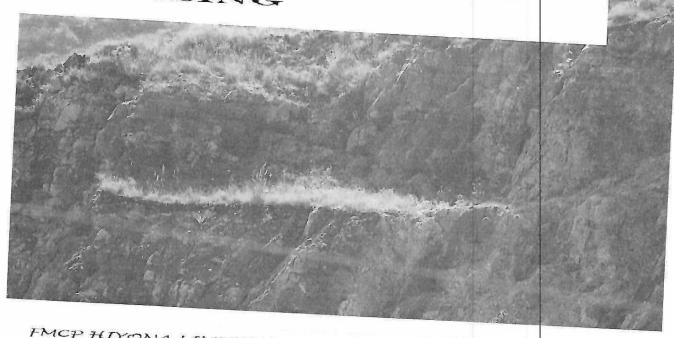
FMCP HIYONA LIMESTONE MINE:

MINED OUT AREA RE-GRASSING

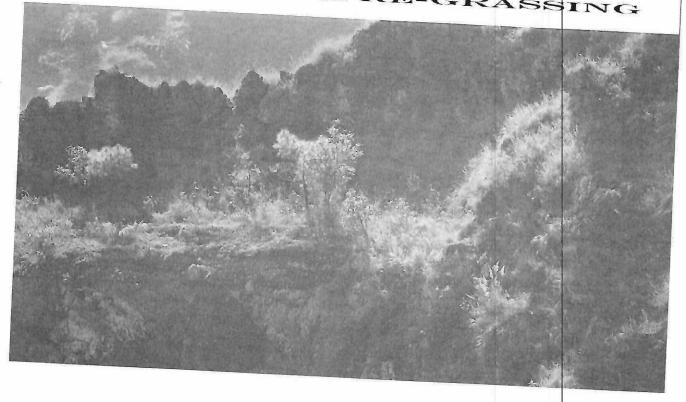
FMCP HIYONA LIMESTONE MINE:

MINED OUT AREA
PLANTATION & RE-GRASSING

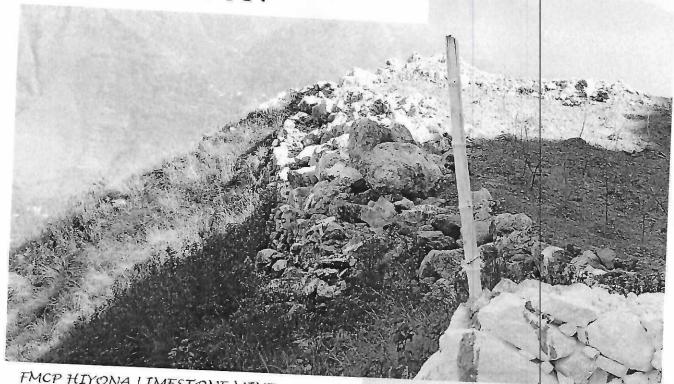
FMCP HIYONA LIMESTONE MINE:

MINED OUT AREA PLANTATION
